The Cost of Maintaining Thermal Protection Systems

Frank E. Jones
NASA-KSC

July 1999

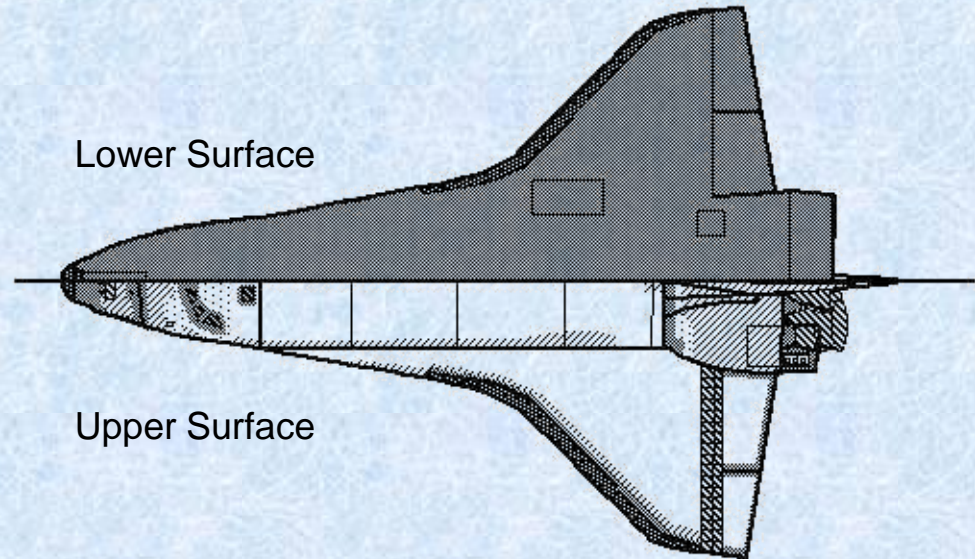
TPS Surfaces

HRSI (Black) Tiles
	LRSI (White) Tiles
	AFRSI Blankets
	FRSI
	RCC
	Glass
	Exposed Metallic Surfaces

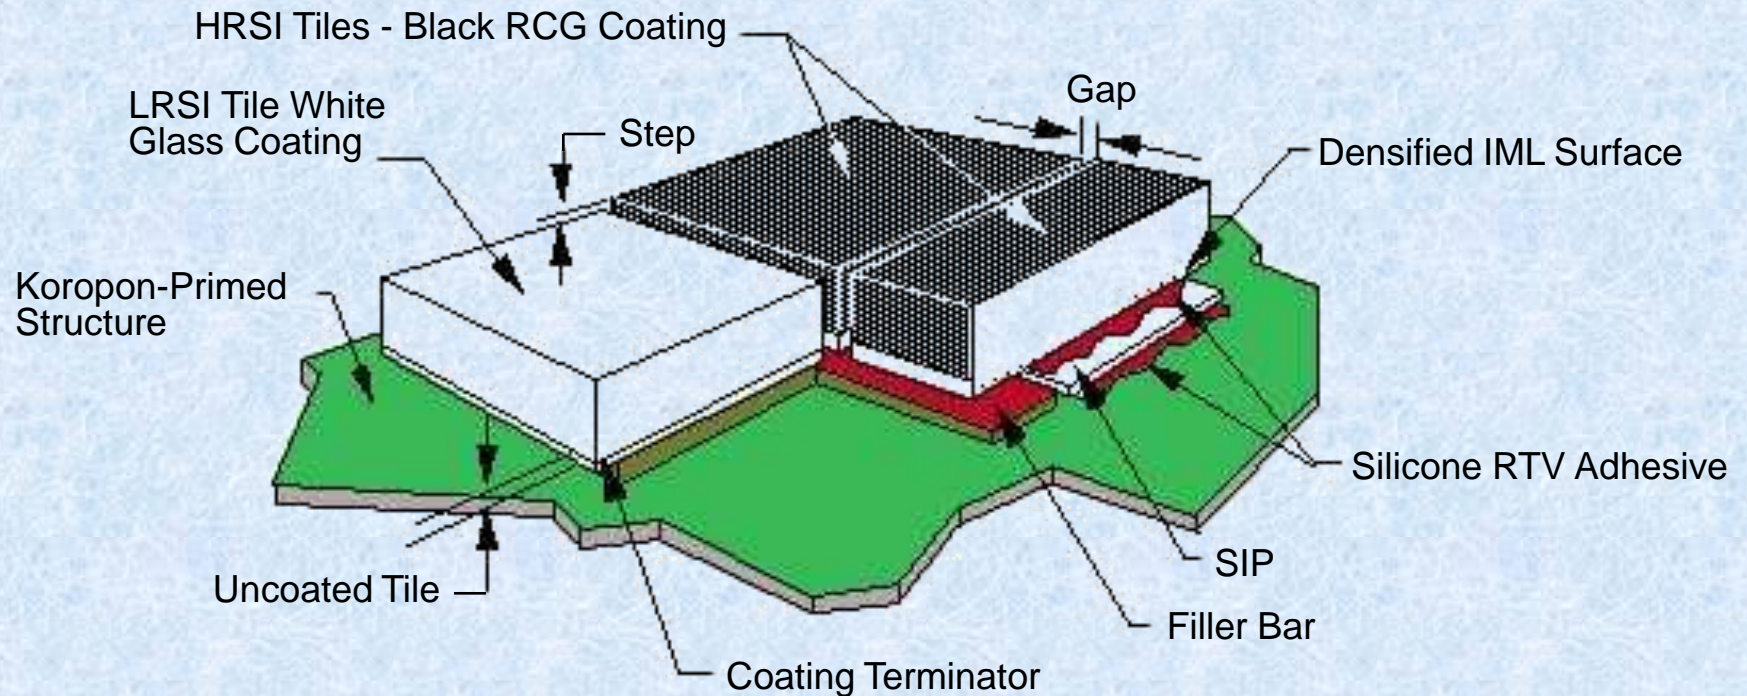
Tile Configuration

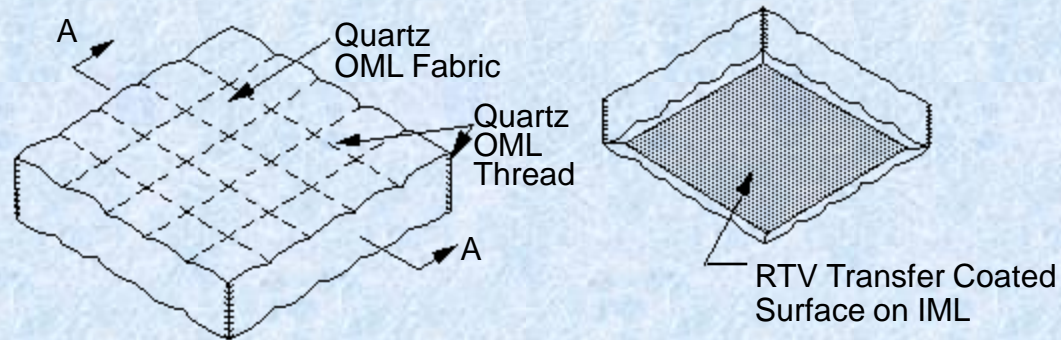
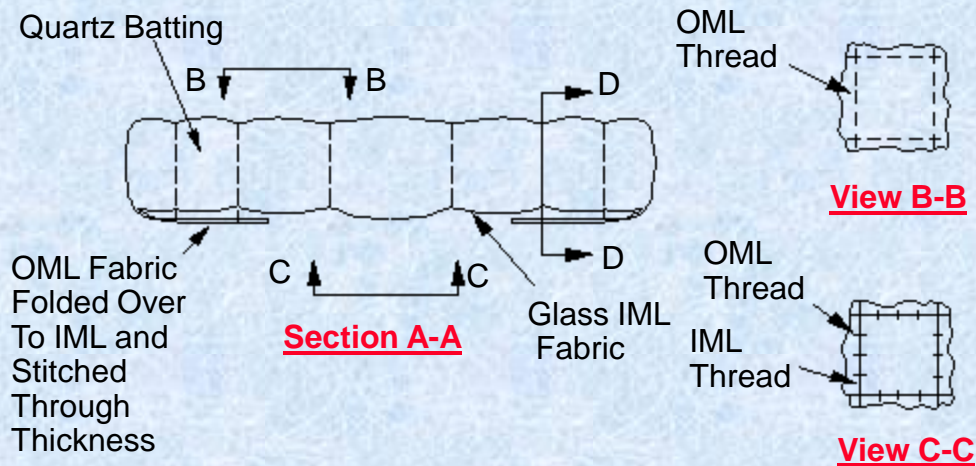
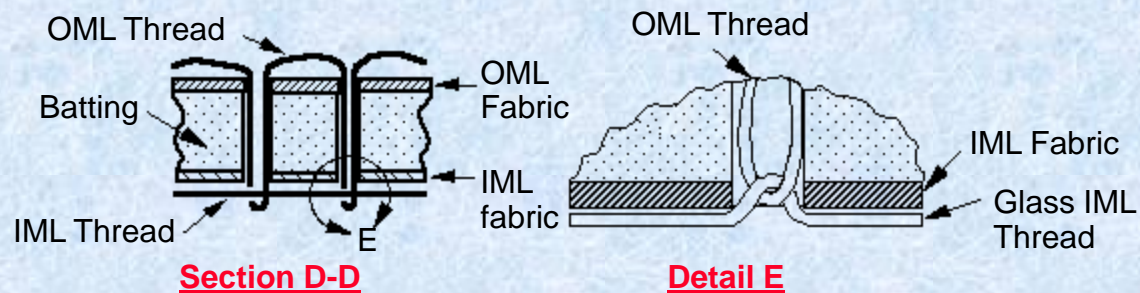
Fibrous Insulation Blankets

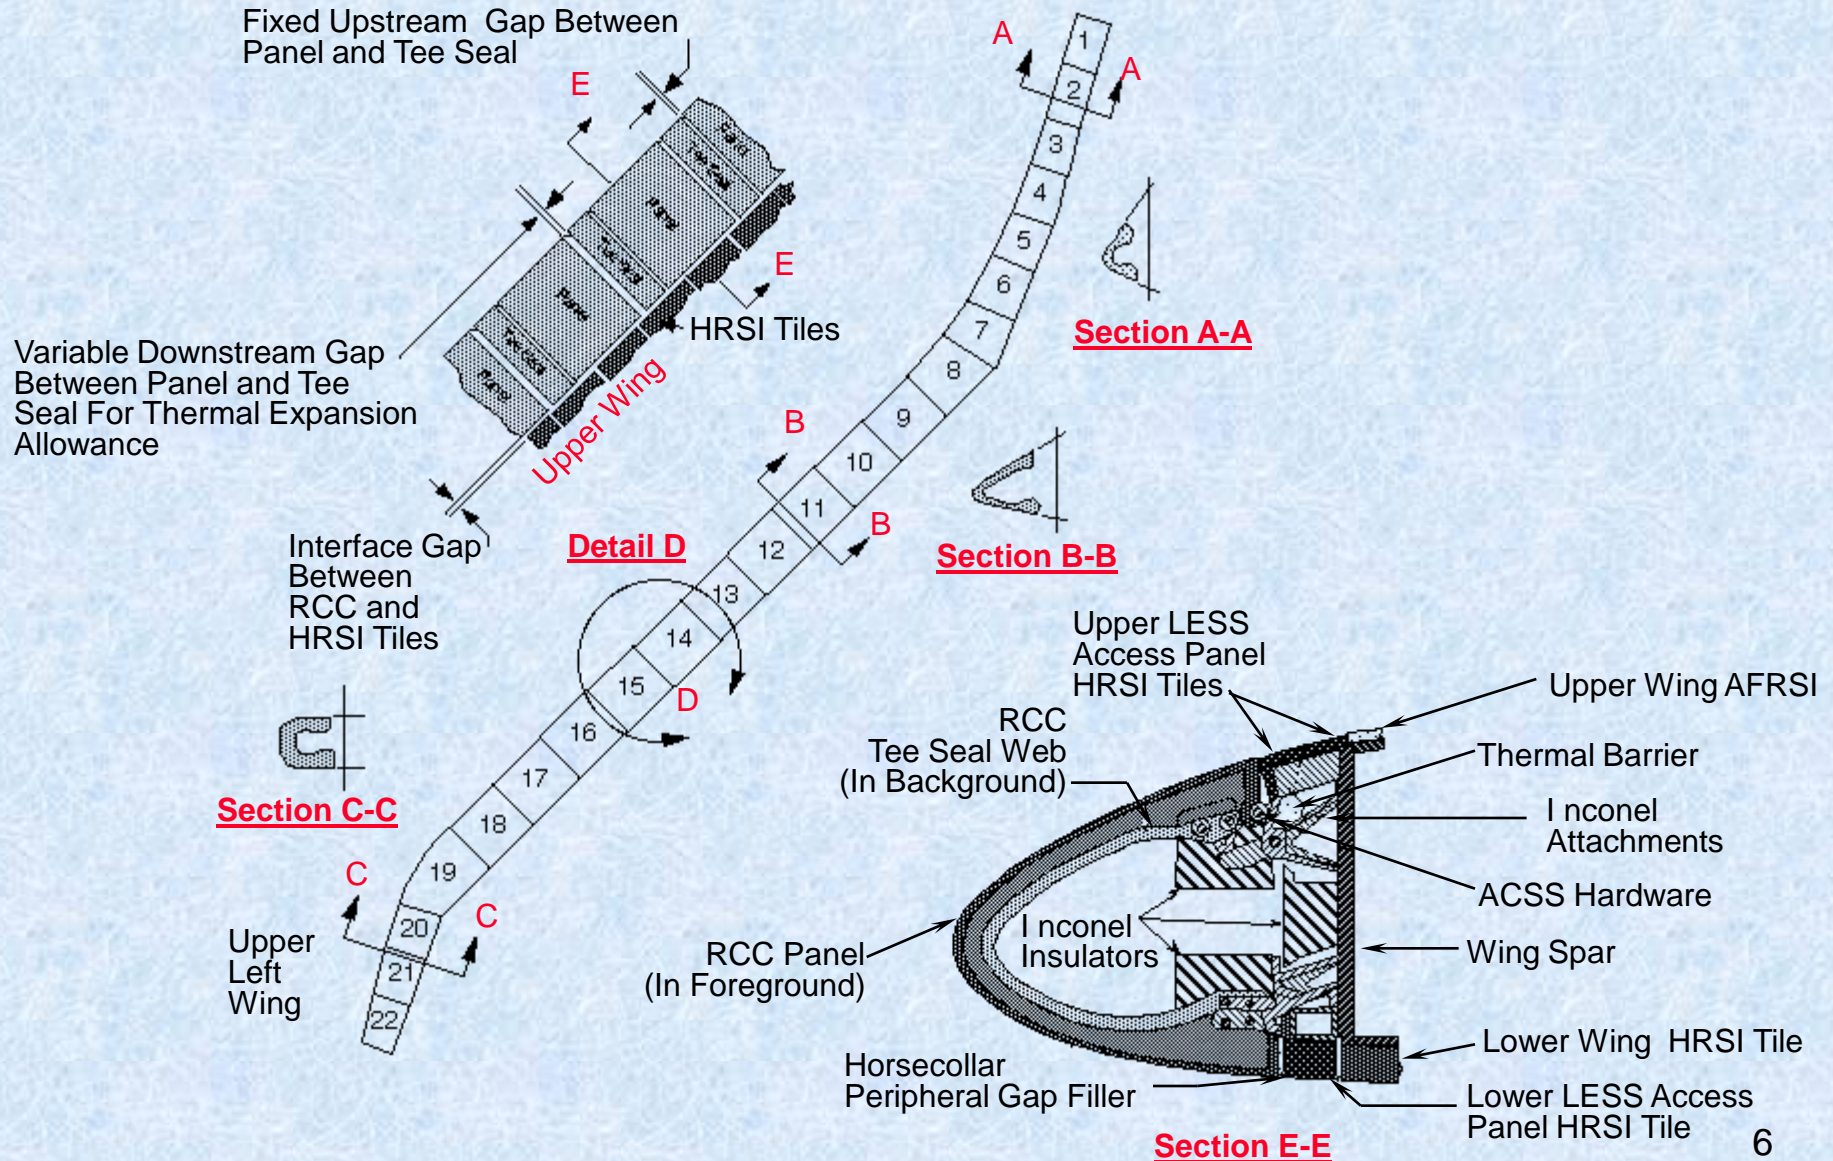
Leading Edge RCC

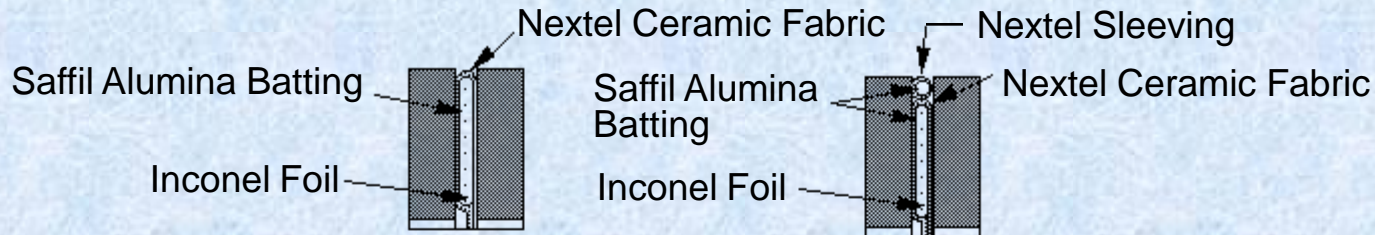
Gap Fillers

Pillow or Pad Type

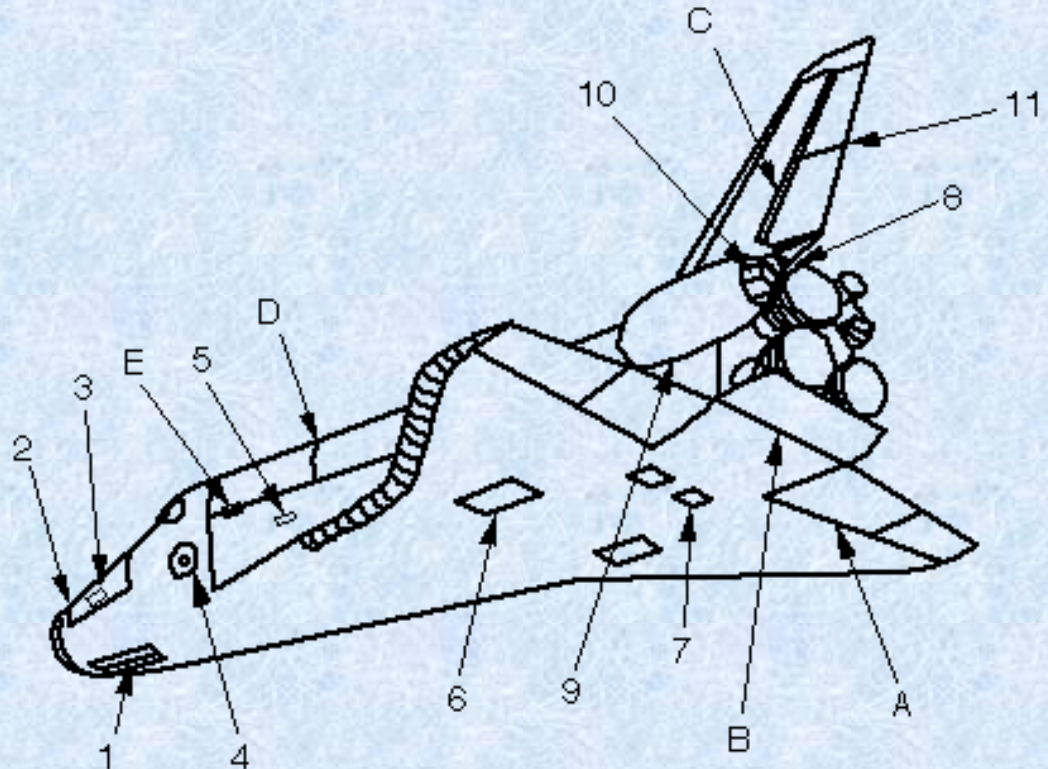
Thermal Barrier & Seal Locations

Thermal Barriers

Aerothermal Seals

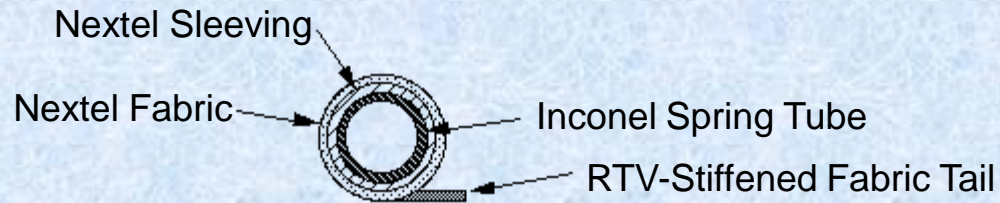
Typical Thermal Barrier

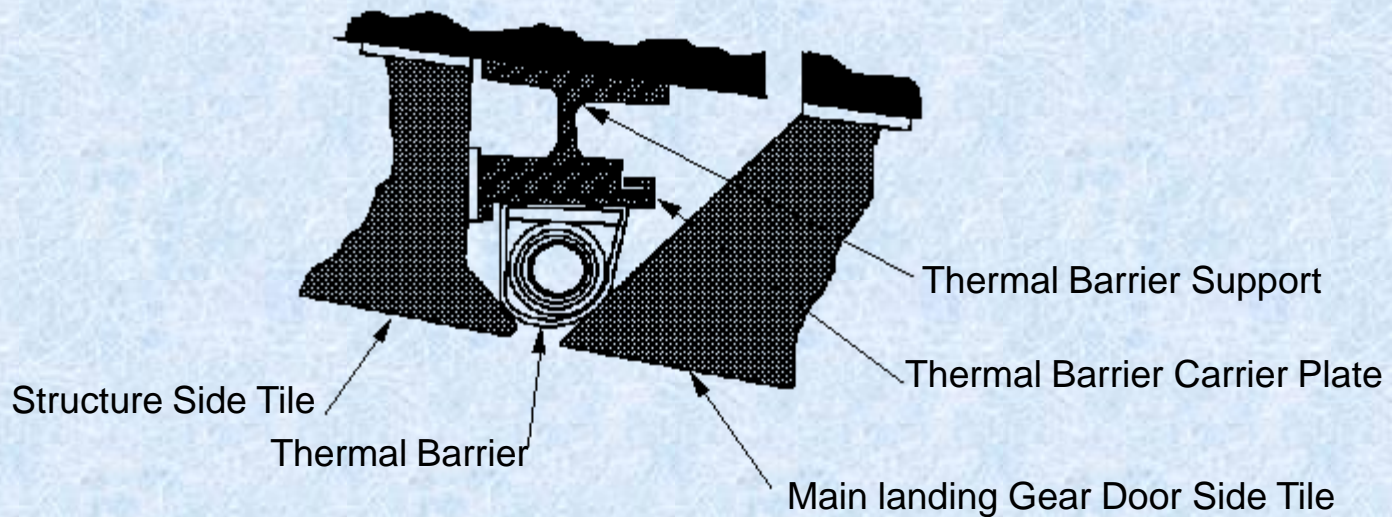
Typical Thermal Barrier Detail

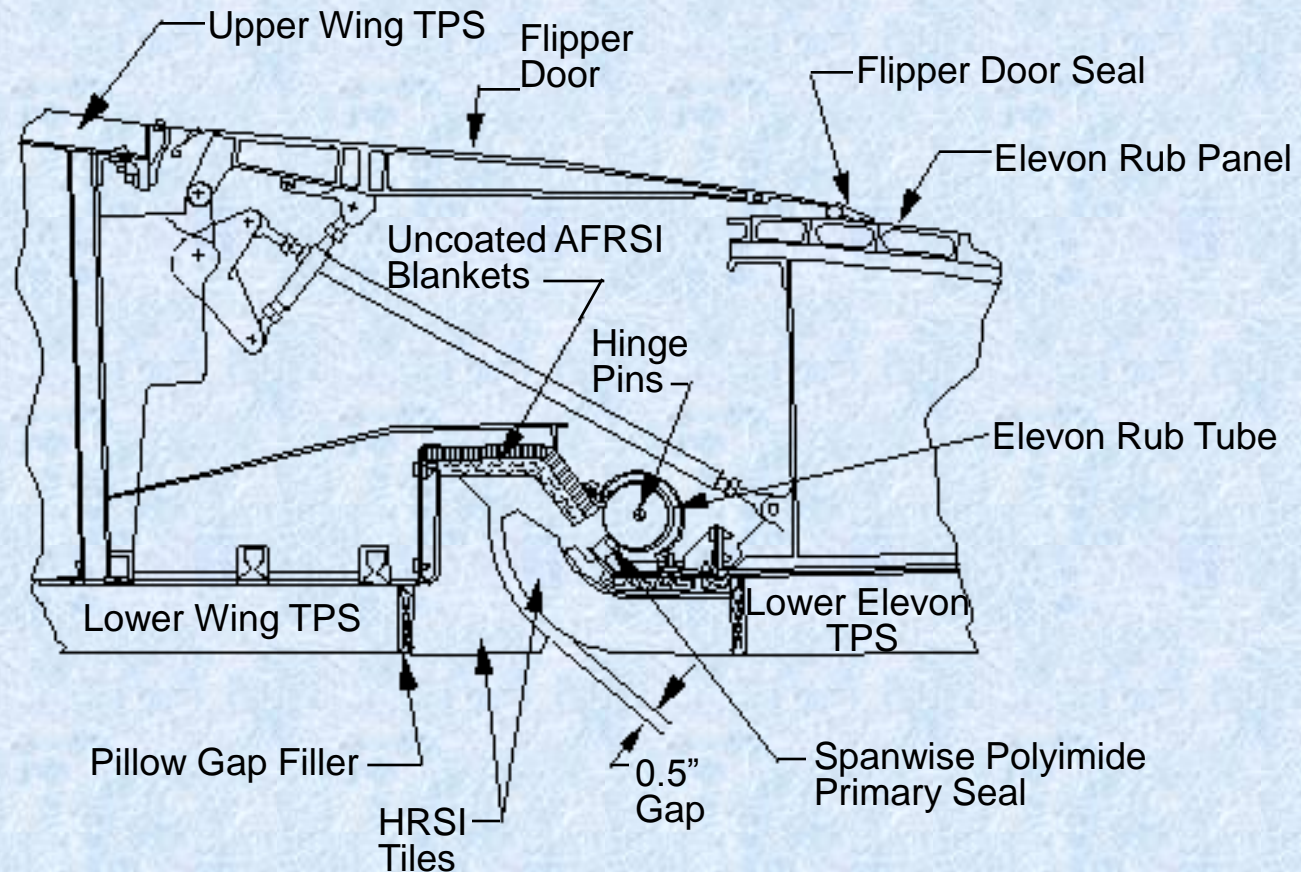
Elevon Cove Seal

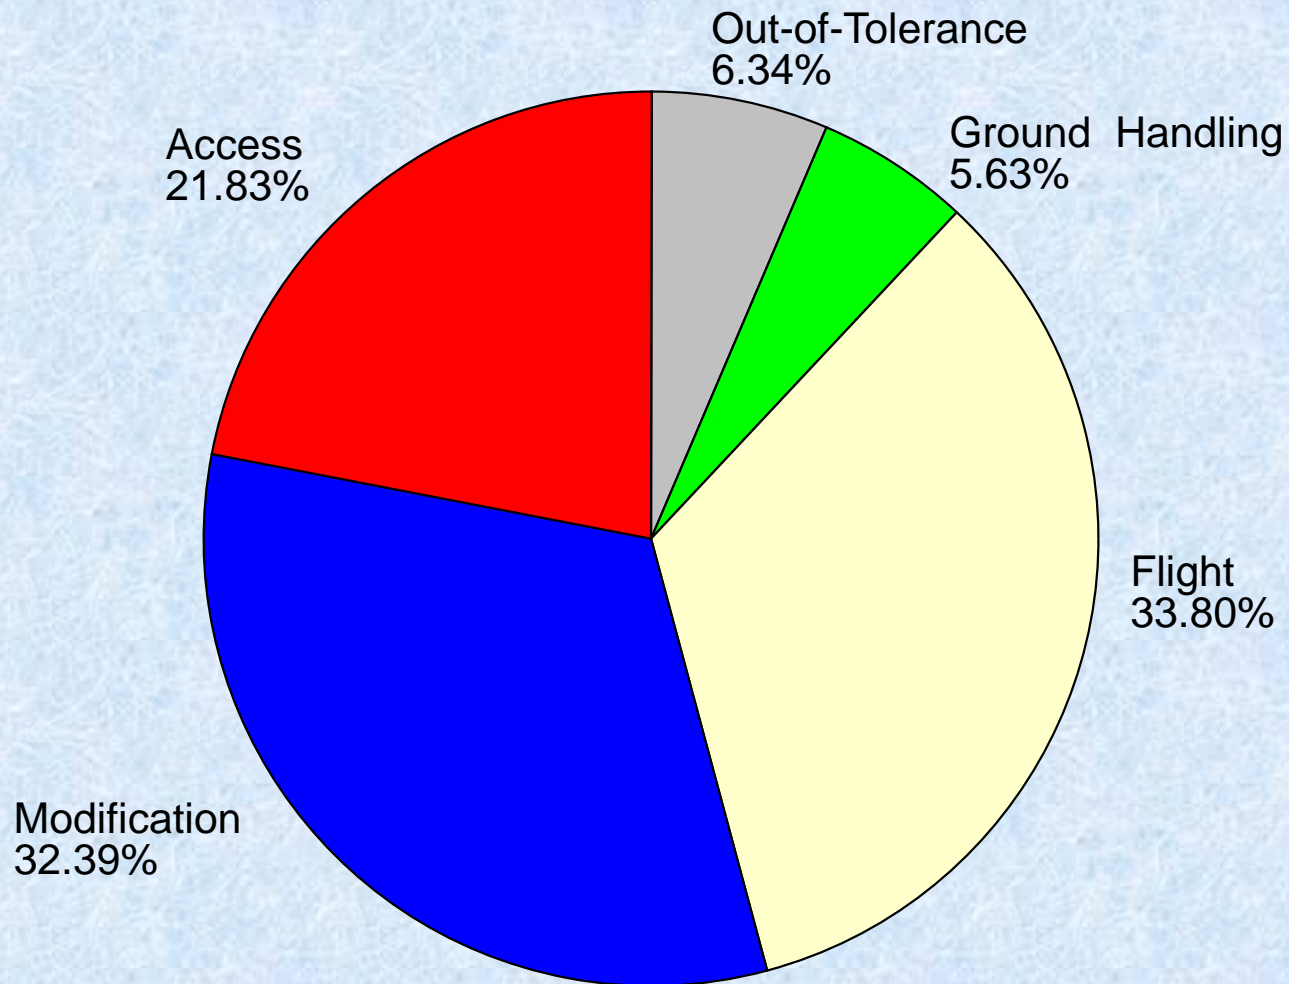
Causes for R&R

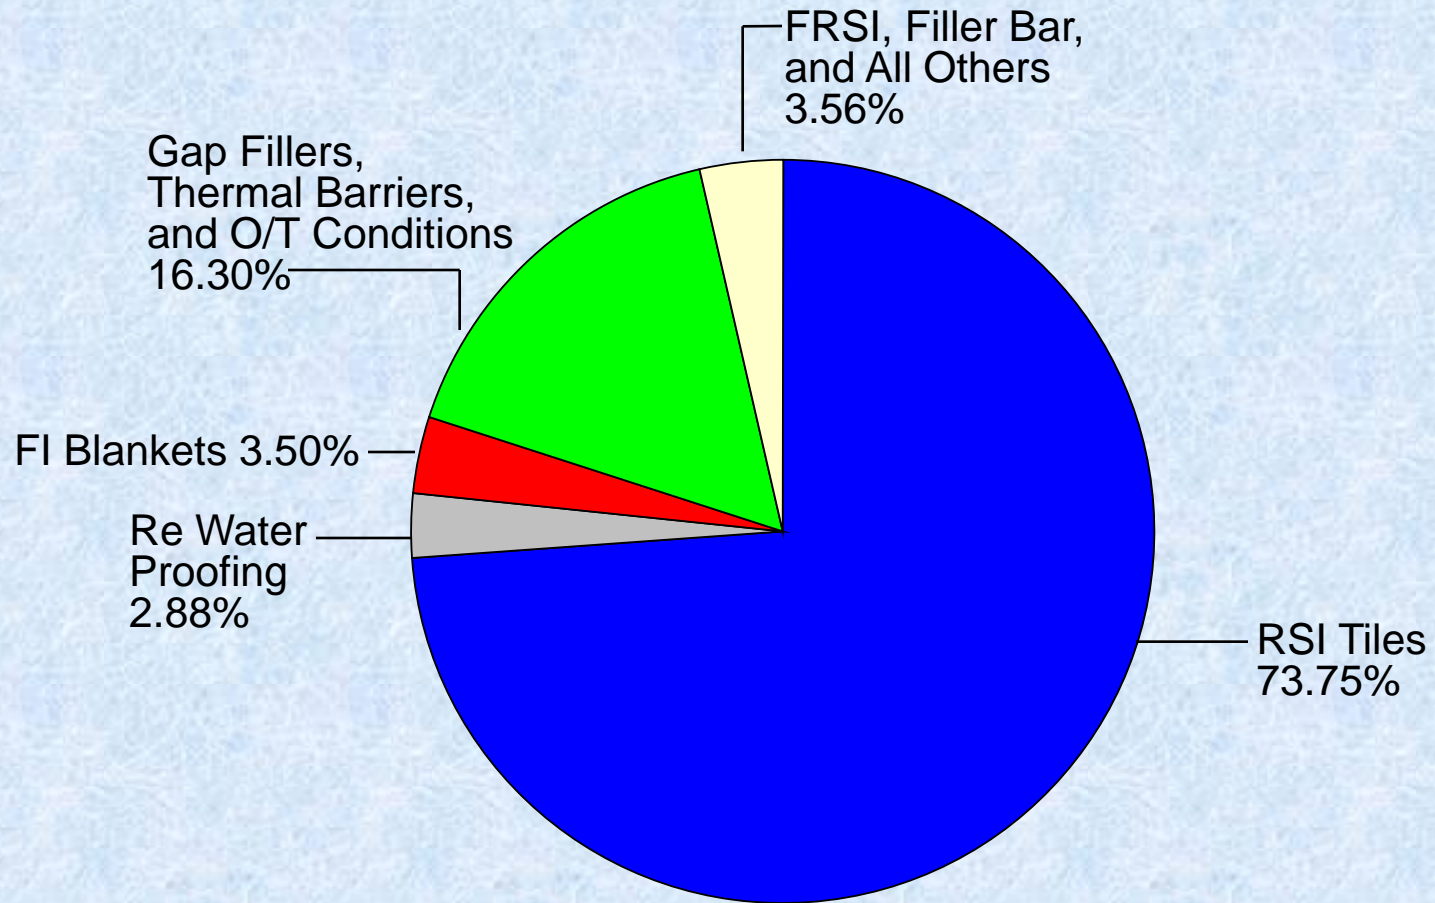
TPS Discrepancies

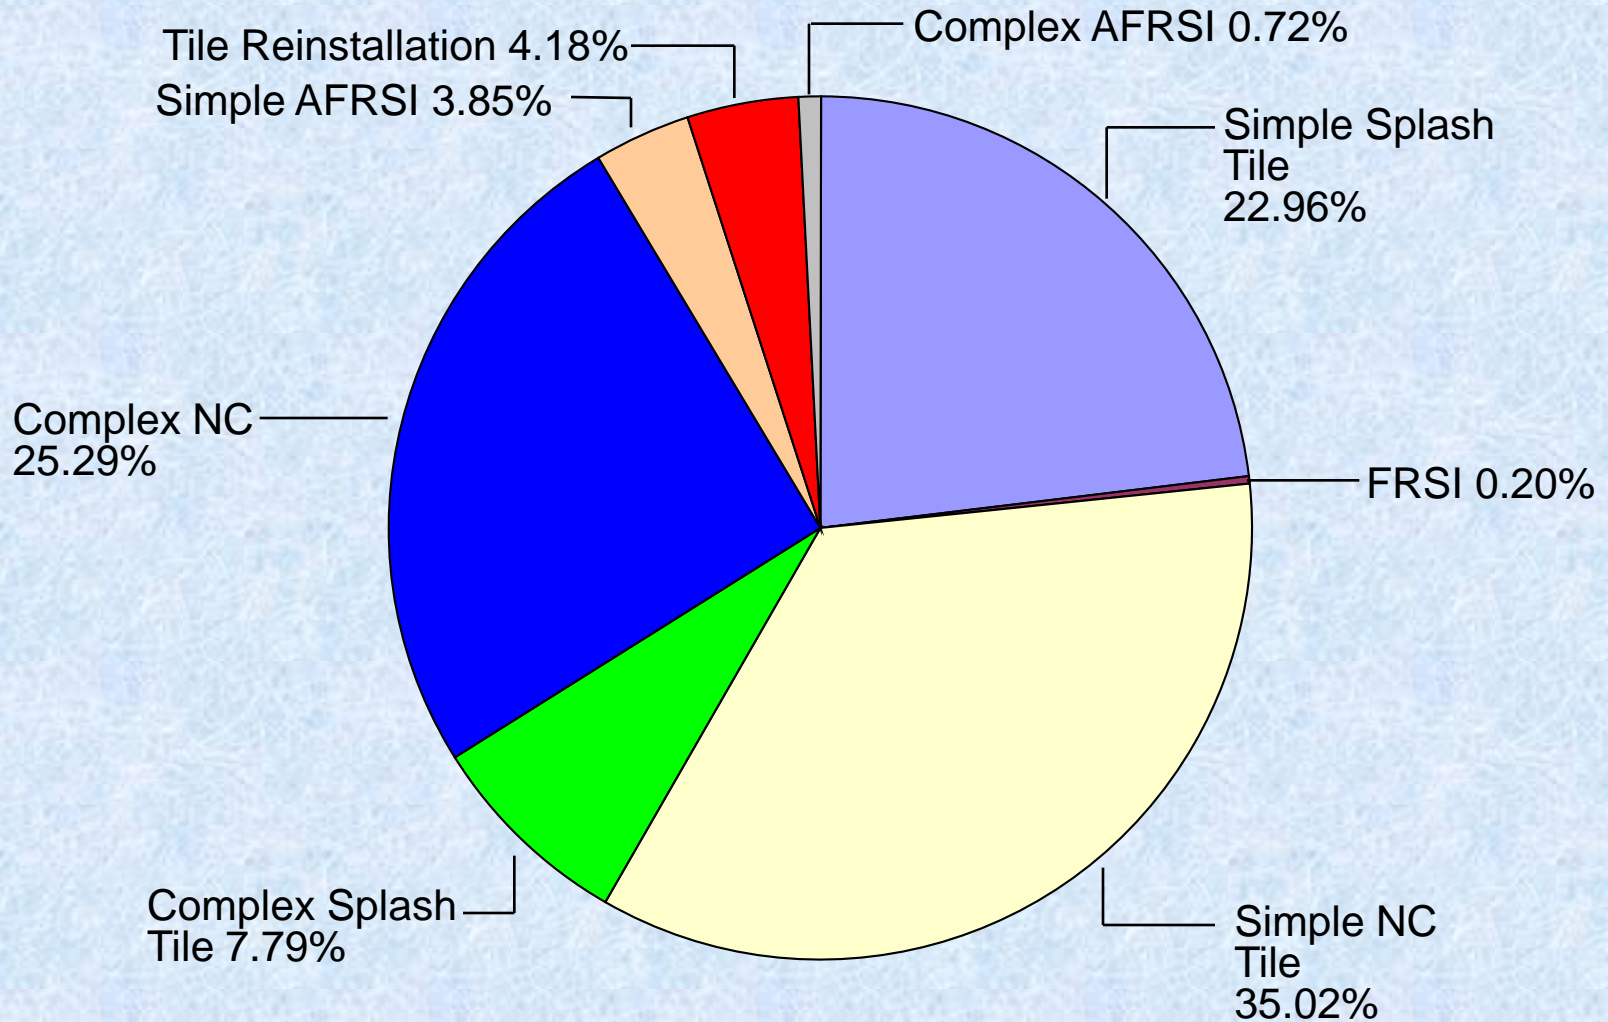
Work Load for Component R&R

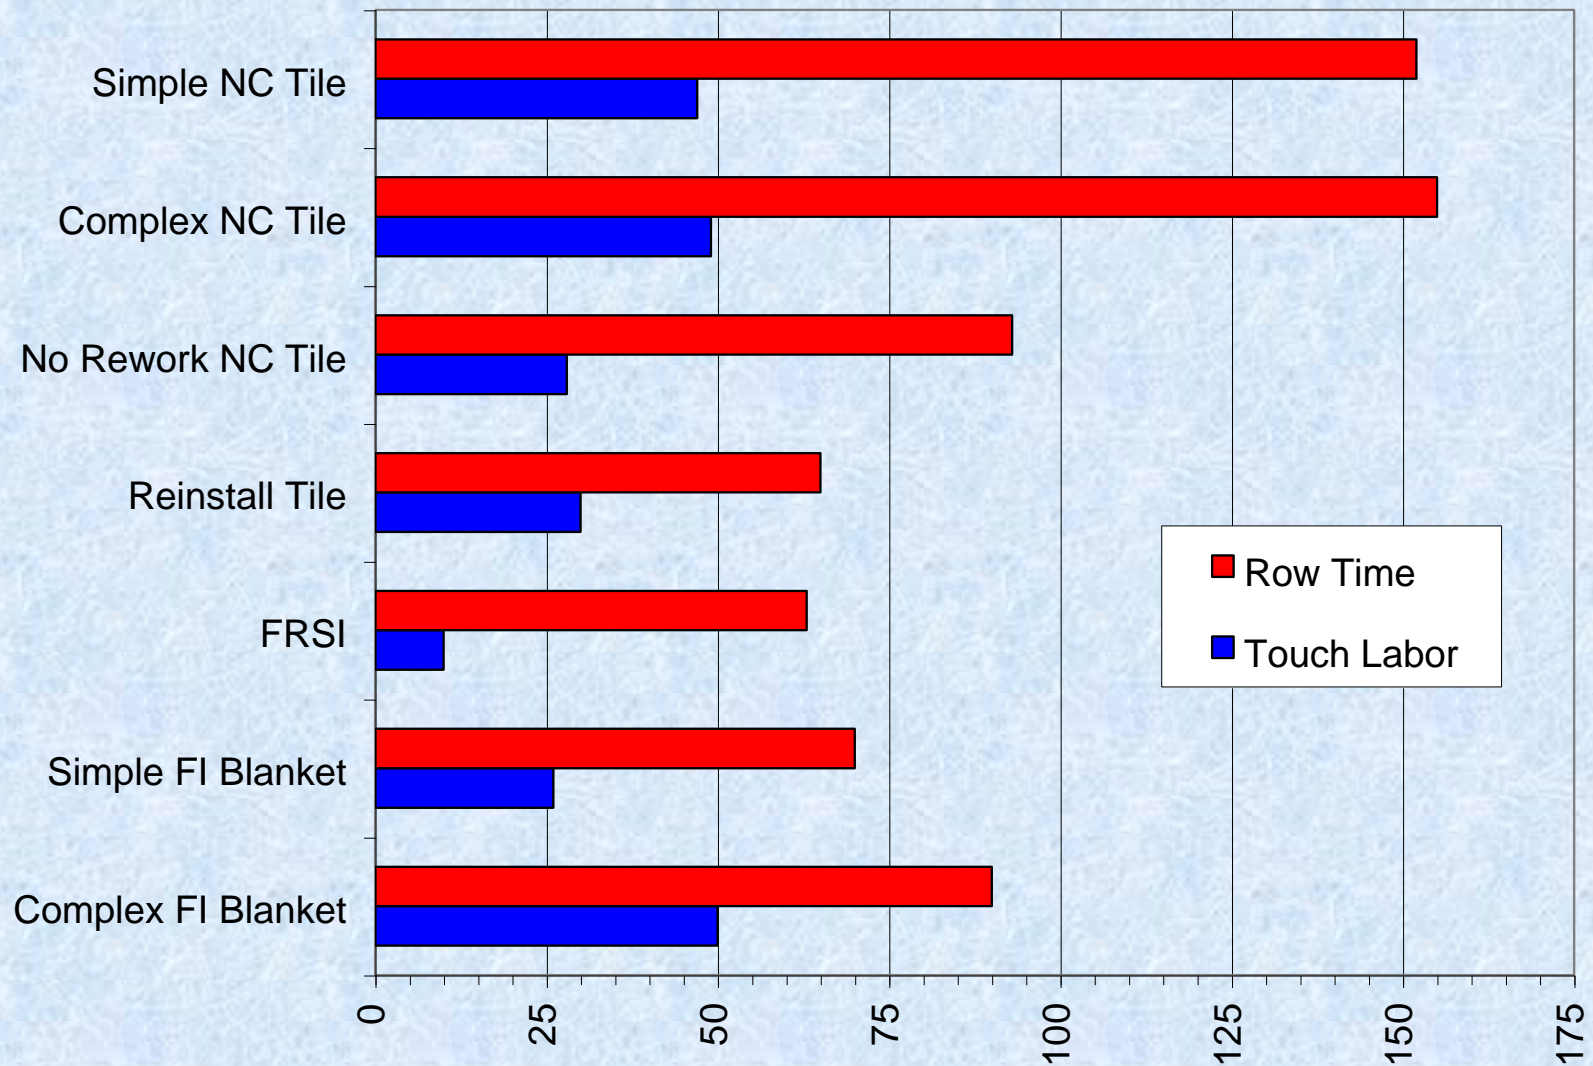
Labor Hours per Type

Labor Touch Time per TPS Type

- **Tile = 2.27 hours/sq.ft.**
- **FIB = 0.16 hours/sq.ft.**
- **FRSI = 0.02 hours/sq.ft.**
- **ET SOFI = 0.70 hours/sq.ft.**

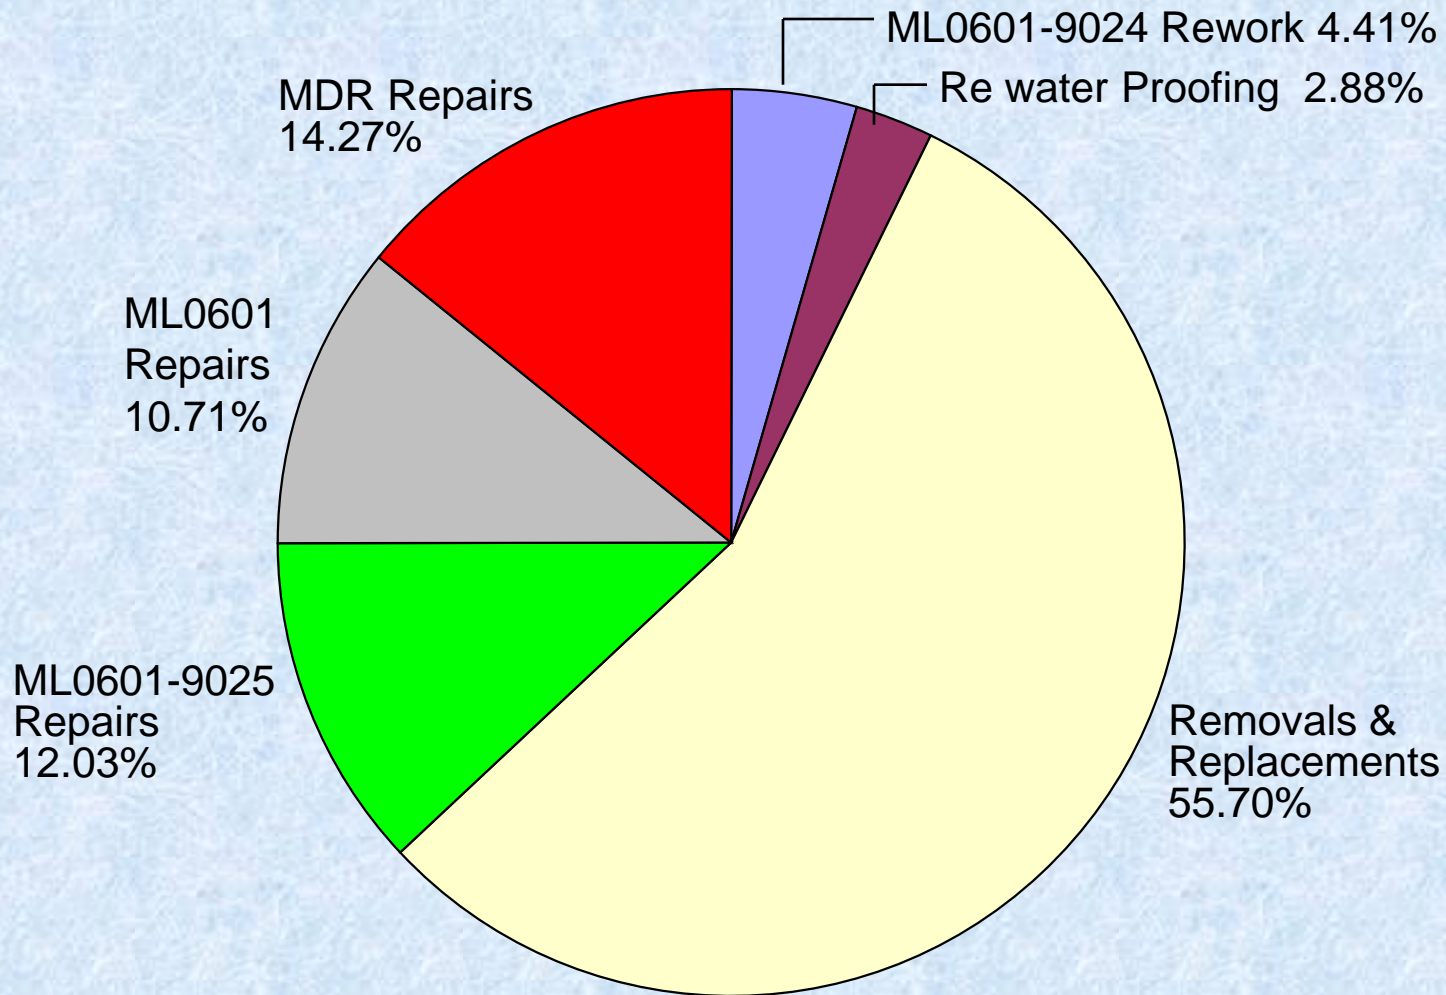
Tech Labor Breakdown
